JOINT TASK FORCE ONE

ARMY GROUND GROUP
(TASK GROUP 1.4)

FINAL REPORT

ATOMIC BOMB TESTS

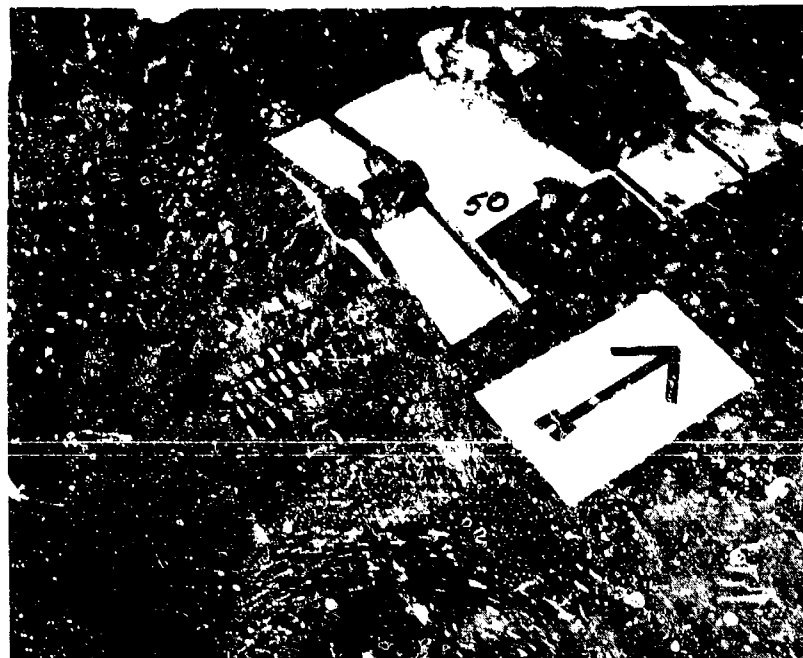
b. Fuse, T.M., M43A3, w/Booster, M20A1 (Item #50). One fuze was displayed in a fiber container, Fig. 283. On the YOG 83, Fig. 284, the heat scorched through one layer of paper and left it tattered. The markings on the tape could not be read since it was partially torn off. On the LST 52, Fig. 282, the fiber container was scorched on the blast side. It was also dented by the straps. No damage was apparent on the remaining target ships.

Fig. 284 - YOG 83 - View of charred fiber container of Item 50 after Test Able.

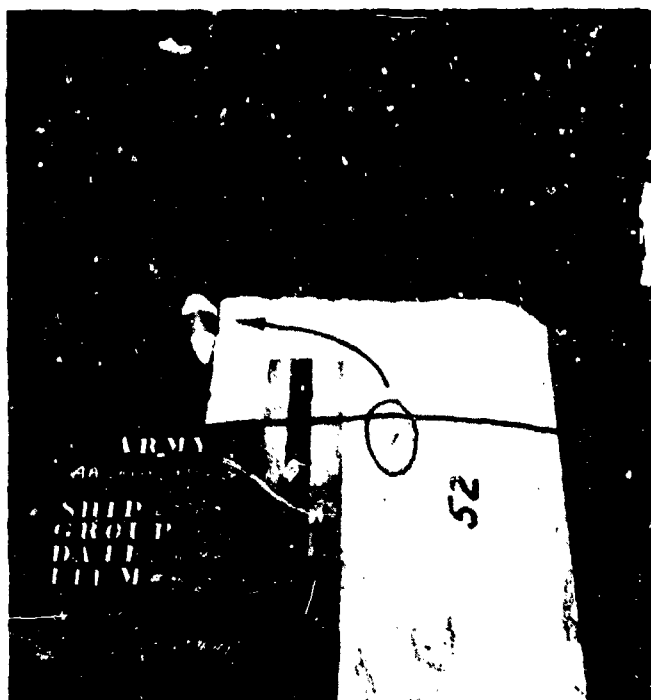
Fig. 291 - LST 52 - View after Test Able
showing the displacement of Item 52.

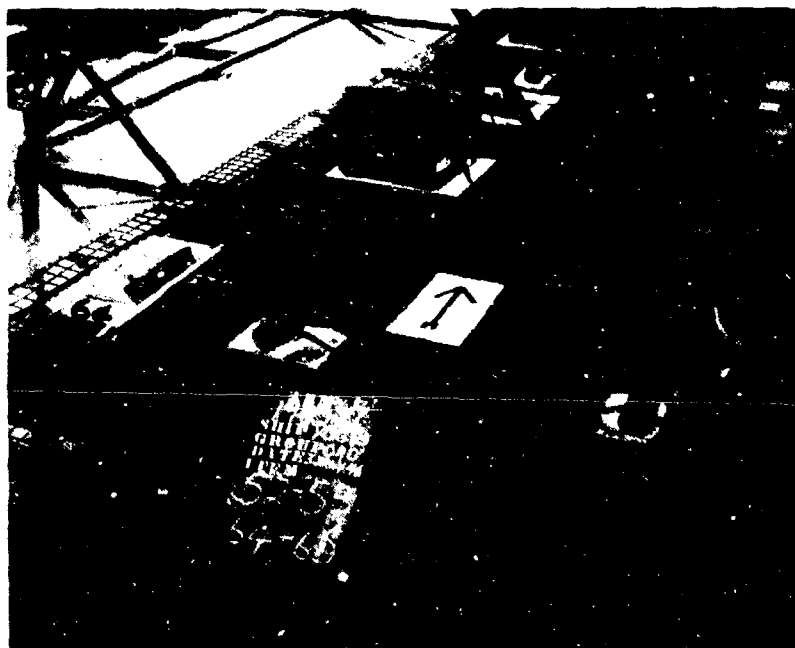
e. Fuse, T.M., M43A1, w/o Booster (Item #53). One fuze was displayed in a fiber container, Fig. 288. On the YOG 83, Fig. 289 and Fig. 292, the container was slightly scorched on the blast side and end. The paper was peeled and tattered. The markings protected by the steel strappings were legible, but all other markings were obliterated. On the LST 52, the fiber container was slightly scorched on the blast side and was dented by the straps. No damage was apparent on the remaining

Fig. 292 - YOG 83 - Damage to Items 52, 53, 64, and 65
after Test Able.

On the YOG 83, Fig. 289 and Fig. 292, the only damage was a slight scorching on the rear of the booster cup. The plate on which the item was displayed was bent upward, by the blast. The fuze remained in position. On the LST 661, the item was masked by a beam. No damage was apparent on the remaining ships.

g. Fuze, P.D., M52A1, w/o Booster (Item #65). One fuze was displayed in a fiber container, Fig. 306. On the YOG 83, Fig. 289 and Fig. 292, the container paper and tape were scorched and peeled. The paint was scorched from the bottom of the container. All markings were obliterated. On the LST 52, Fig. 307, the container was crushed by a falling hatch cover. The container had been dented by the straps when securing it to the pallet. On the LST 661, the container had been struck by a wooden hatch cover but was undamaged. No damage was apparent on the other ships.

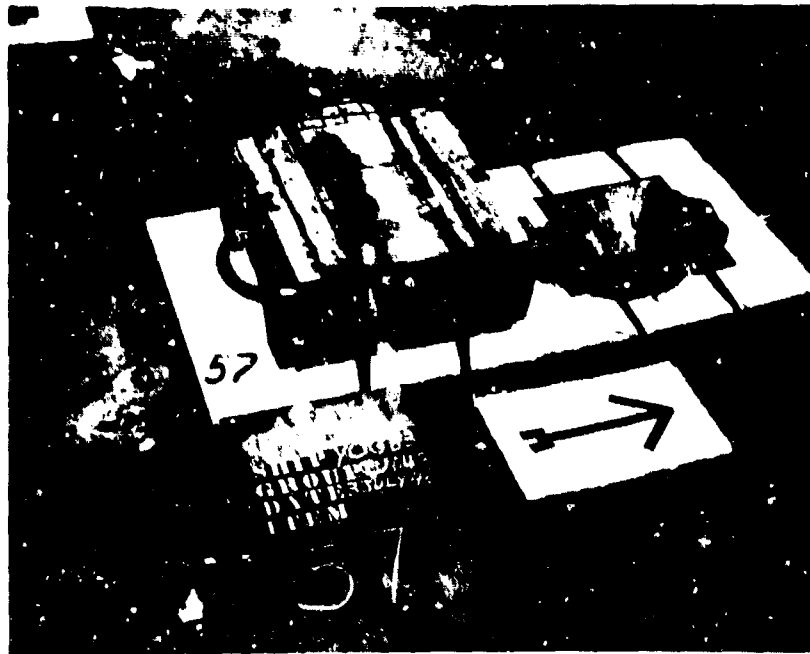
i. Fuse, P.D., M48A2, w/Booster, M21A1 (Item #57). Twenty-three fuzes were displayed in a wooden box. On the YOG 83, Fig. 296 and Fig. 297, the box was slightly scorched on the blast side and end. The nomenclature was obliterated on these two sides but legible on the others. The rope handle was also scorched. Mask marks made by the strapping were clearly visible on the blast side. On the LST 52, the box was scorched on the blast side, but was still serviceable. On the LST 661, all markings were obliterated from the box on the side directly exposed to the blast. No damage was apparent on the remaining LST's.

Fig. 297 - YOG 83 - View after Test Able of the scorched box of Item 57.

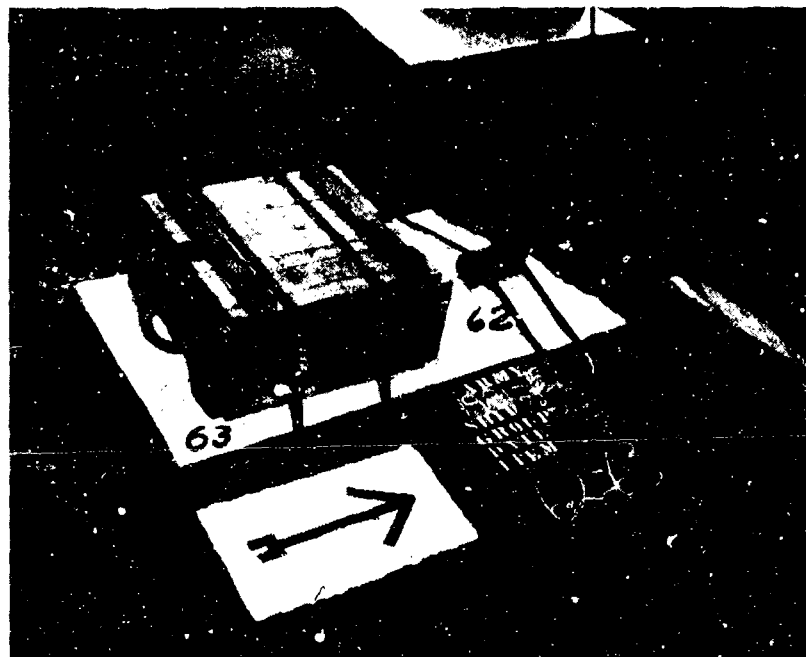
n. Fuze, P.D., M52A1, w/Booster (Item #62). One fuze was displayed in a fiber container, Fig. 302. On the YOG 83, Fig. 303 and Fig. 304, one layer of paper on the container was scorched through and tattered on the side toward the blast. The fiber container, on the LST 52, was scorched on the blast side and dented by the straps. The fuze was still serviceable. No damage was apparent on the remaining LST's.

o. Fuze, P.D., M52A1, w/Booster (Item #63). Twenty-three fuzes were displayed in a wooden box, Fig. 305. On the YOG 83, Fig. 303 and Fig. 304, the rope handle was missing from one end prior to Test Able. After Test Able, the blast side and end were slightly scorched. The markings on these sides were only partially legible. The rope handle and the cleats toward the blast were also scorched. Mask marks caused by the straps were clearly visible on the scorched side. On the LST 52, the box was scorched on the blast side, but was still serviceable. No damage was apparent on the remaining ships.

Fig. 304 - YOG 83 - The scorched container of Item 62 and the scorched box of Item 63 after Test Able.

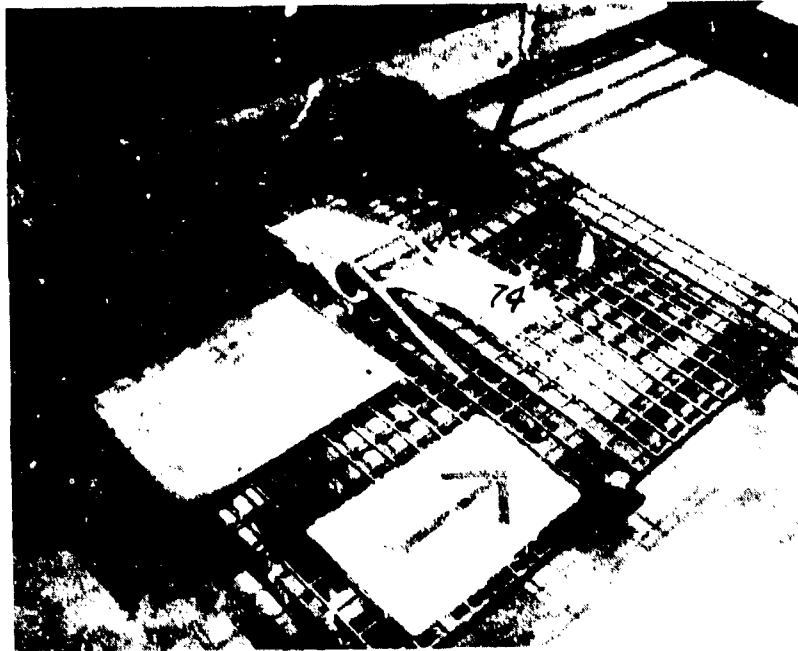
Fig. 315 - YOG 83 - Damage to Item 74 after Test Able.

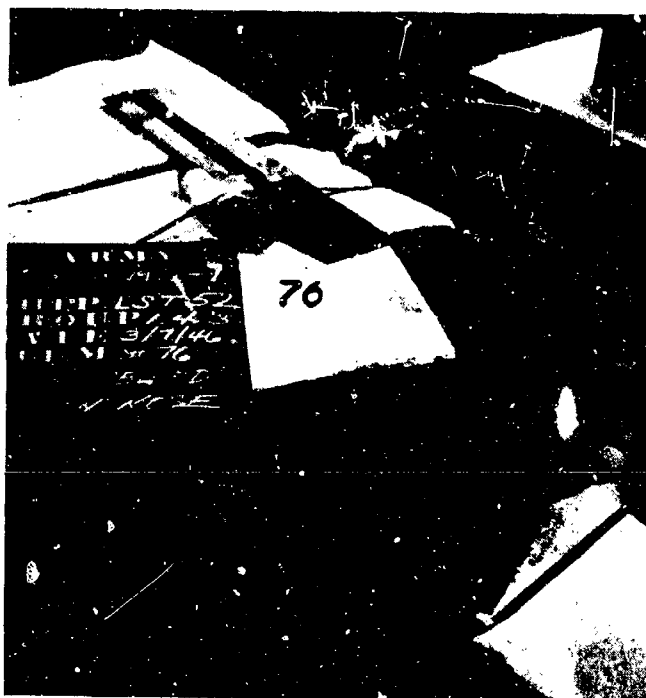
Fig. 318 - LST 52 - View after Test Able showing melted wax on nose of Item 76.

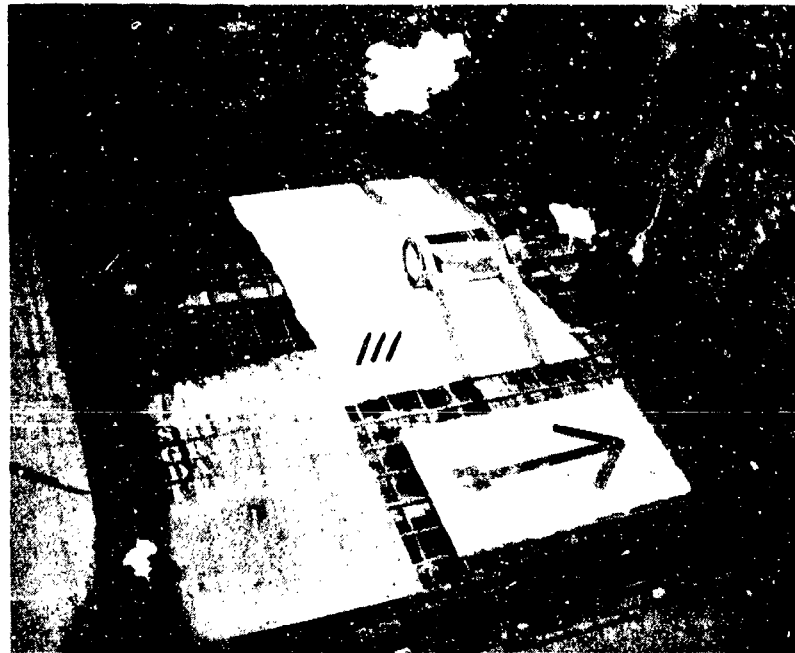
Fig. 324 - YOG 83 - Damage to Item 111 after Test Able.

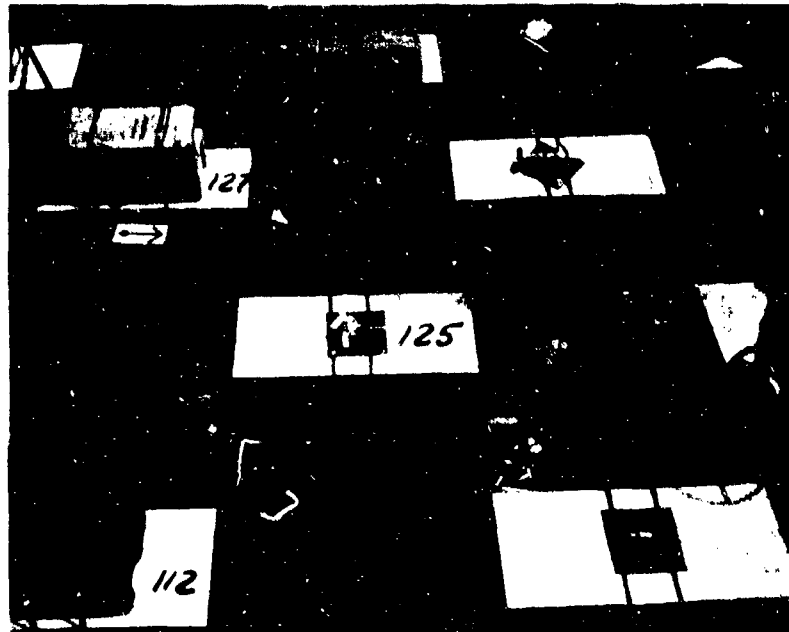
g. Fuse, Bomb, Nose, AN-M103A1, w/Booster, (Item #112). Twenty-three of these fuses were displayed in a wood box, Fig. 312. On the YOG 83, Fig. 325 and Fig. 326, the box was scorched on the blast side and end and partially on the top. The exposed rope handle was also scorched. The markings on the scorched side and end were obliterated but those on the top were legible. The box was shifted approximately 1-1/2" by the blast. The box was scorched on the LST 52, but was still serviceable. On the LST 661, the box was slightly scorched. All markings on the side of the box directly exposed to the blast were obliterated. On the remaining ships, there was no damage apparent.

Fig. 325 - YOG 83 - Method of displaying Items 112, 125, and 127.

p. Fuse, Bomb, Nose, VT, T51M1 (M166) w/Booster (Item #125). One fuse was displayed bare on a metal plate, Fig. 342. On the YOG 83, Fig. 325 and Fig. 343, the plastic head and wing facing the blast were scorched. The body was slightly corroded by rain. All safety pins were in place, but parts of their tags were burned off. The body was scorched and the warning on the wing was discolored. The fuse body and plastic head were scorched on the top, on the LST 52. No damage was apparent on the remaining ships.

Fig. 346. On the YOG 83, Fig. 325 and Fig. 347, the exposed side was scorched and half of the markings were illegible. A small stone was driven approximately 3/16" into the box. The hardware on the same side of the box was scorched. On the LST 52, the box was scorched but remained serviceable. On the LST 661, the box was slightly scorched. No damage was apparent on the remaining ships.

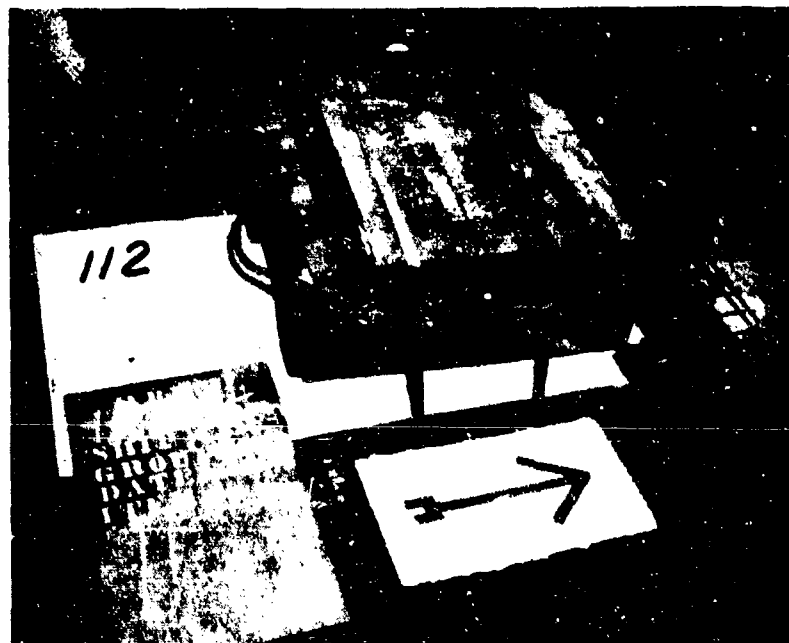
Fig. 326 - YOG 83 - Damage to Item 112 after Test Able.

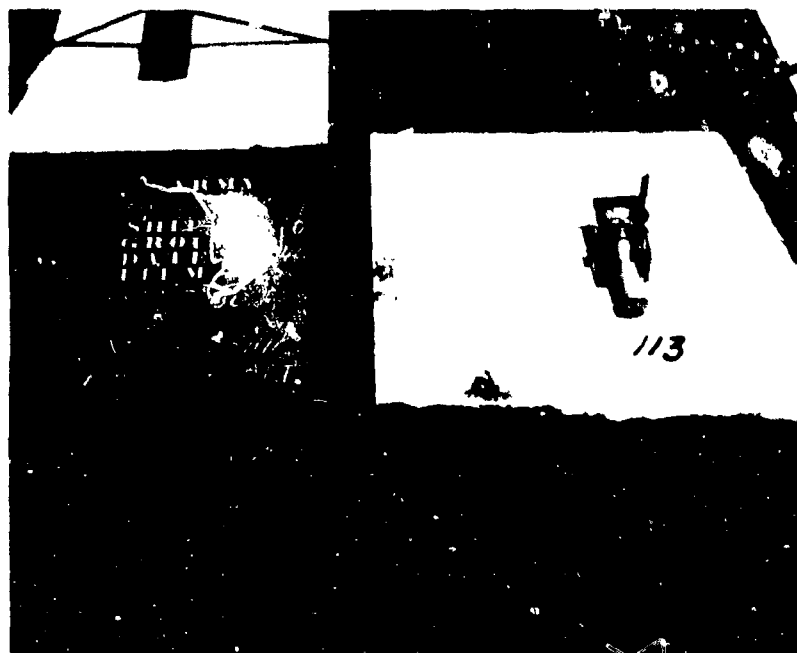
h. Fuse, Bomb, Nose, AN-M103A1, w/o Booster (Item #113). One fuse was displayed bare on a sheet metal plate, Fig. 327. On the YOG 83, the fuse had been corroded by rain. On the LSTs 52, 661, 220 and 545, there was no apparent damage.

Fig. 327 - LST 220 - Method of securing Item 113.

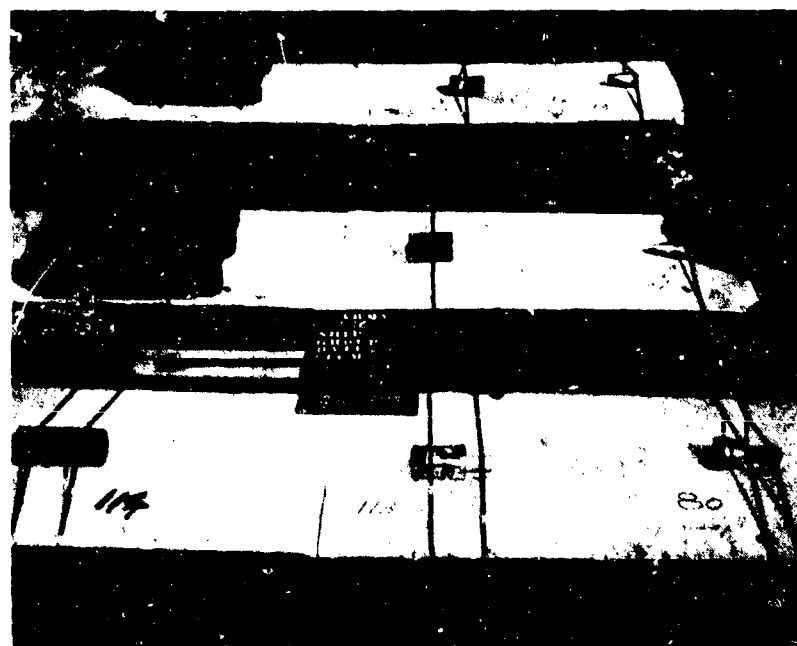
i. Fuse, Bomb, Nose, AN-M103A1, w/o Booster (Item #114). This fuse was displayed in a metal container, Fig. 328. On the YOG 83, Fig. 329 and Fig. 330, the can was badly damaged by an unknown flying object. The can was not damaged by the blast itself. It appears to have been scorched over an area of 2" x 4-1/2" on the blast side. The base of the can was also scorched. Fifty percent of the markings were obliterated. No damage was sustained on the remaining ships.

Fig. 328 - LST 52 - Method of displaying Item 114.

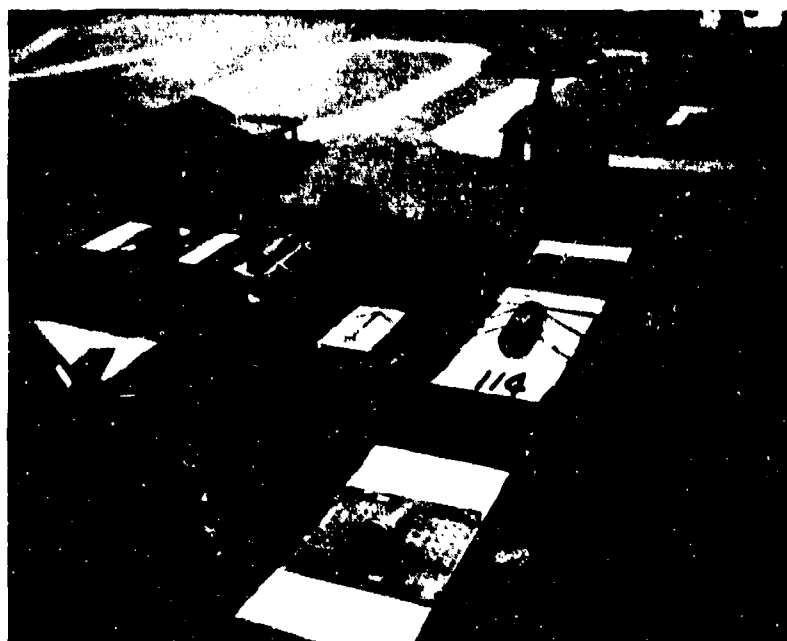
Fig. 329 - YOG 83 - Method of displaying Items 114 and 123.

i. Fuse, Flare, M.T., M111A2, w/Booster (Item #118). Twenty-three of these fuzes were displayed in a wooden box, Fig. 337. On the YOG 83, Fig. 323 and Fig. 338, the blast side and end were scorched. The markings on the side were illegible, but those on the end were legible because the rope masked them. The box was shifted approximately 1/4" by the blast. On the LST 52, the box was scorched on the blast side but was still serviceable. On the LST 661, the box was also slightly scorched. The markings were legible. No damage was apparent on the remaining ships.

n. Fuse, Bomb, Tail, M112 (Item #123). One fuse was displayed in a metal can, Fig. 341. On the YOG 83, Fig. 329 and Fig. 330, the lid of the can had been displaced 1/4". The end and side of the can exposed to the blast were slightly scorched. Rust was found around the base of the can. On the LST 52, the can was slightly scorched on the blast side. It had been dented when it was secured to the pallet. No damage was apparent on the remaining ships.

o. Fuse, Bomb, Tail, M112 (Item #124). Twenty-three of these fuses were displayed in a wood box, Fig. 331. On the YOG 83, Fig. 217 and Fig. 329, only very slight scorching of the blast side of the box resulted. The markings remained legible. The box had been moved 1" by the blast. The box was scorched on the blast side on the LST 52 even though it was partially masked. The front tie-down strap was broken. On the LST 661, the box was slightly scorched, but the markings were still legible. No damage was reported on the remaining ships.

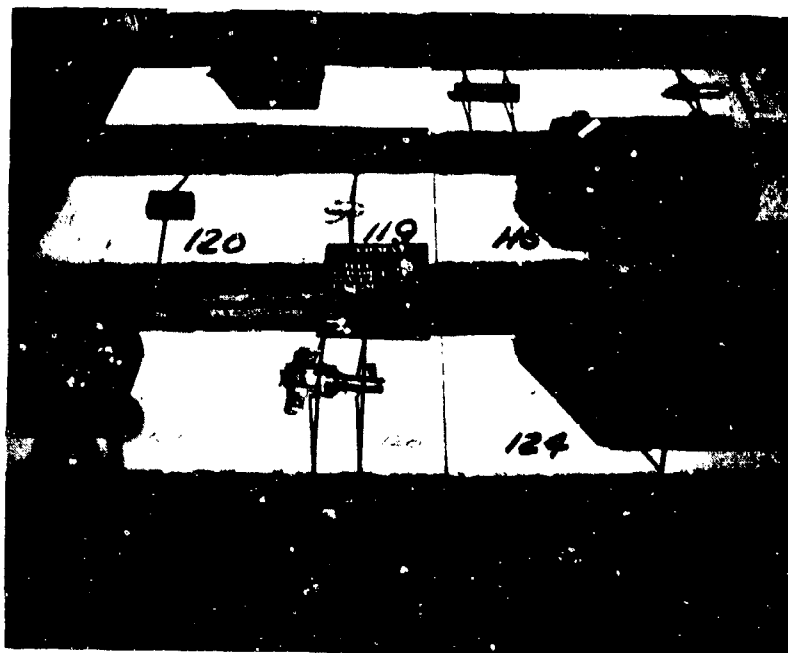
j. Fuse, Bomb, Nose, AN-M103A1, w/o Booster (Item #115). Twenty-three of these fuses were displayed in a wood box, Fig. 331. On the YOG 83, Fig. 332 and Fig. 333, the end and side exposed to the blast were completely scorched. The top was partially scorched. The markings on the end were illegible. Those on the side and top were only partially obliterated. The rope was frayed, scorched, and blown loose from the exposed cleat. The box was scorched on the blast side on the LST 52. On the LST 661, the box was slightly scorched but the markings were legible. No damage was apparent on the LSTs 220 and 545.

Fig. 331 - LST 52 - Method of displaying Items 115, 119, 120 and 124.

j. Fuse, Flare, M.T., M111A2, w/o Booster (Item #119). One fuse was displayed bare on a metal plate, Fig. 331. On the YOG 83, the fuse was corroded due to rain. No primary damage was sustained on this or any of the other target ships.

k. Fuse, Flare, M.T., M111A2, w/o Booster (Item #120). One fuse was displayed in a metal can, Fig. 331. On the YOG 83, Fig. 332 and Fig. 339, the paint was slightly scorched on the bottom of the can and in an area approximately 1-1/2" x 3" on the side toward the blast. The stencilling was slightly obliterated by the heat. On the LST 52, the can was scorched on the blast side. It was dented by the straps, when secured to the pallet. No damage was apparent on the remaining ships.

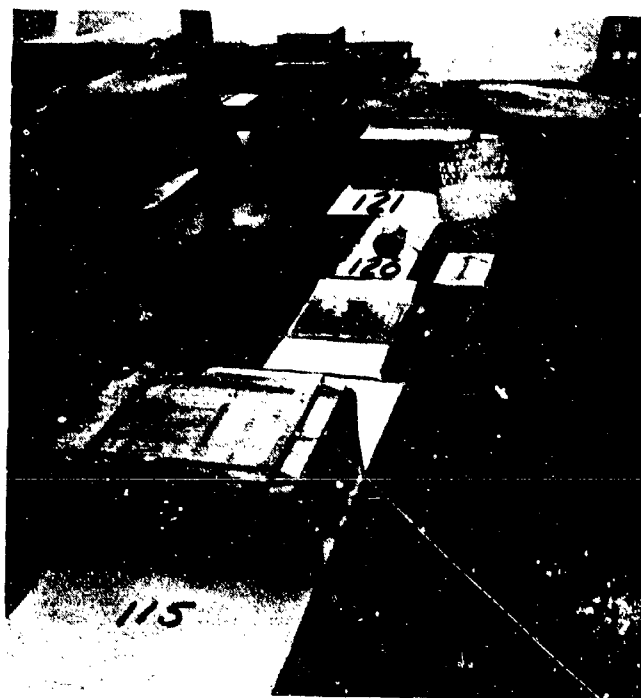
Fig. 332 - YOG 83 - Method of securing Items 115, 120, and 121.

l. Fuse, Flare, M.T., M111A2, w/o Booster (Item #121). Twenty-three fuzes were displayed in a wood box, Fig. 340. On the YOG 83, Fig. 332 and Fig. 339, the top was slightly scorched, obliterating the markings slightly. The end nearest the blast was slightly scorched, but the markings were legible. The blast side was badly scorched, no markings were legible. The box was shifted approximately 1/3". The box was scorched on the blast side, on the LST 52. On the LST 661, the box was slightly scorched, but the markings were legible. No damage was apparent

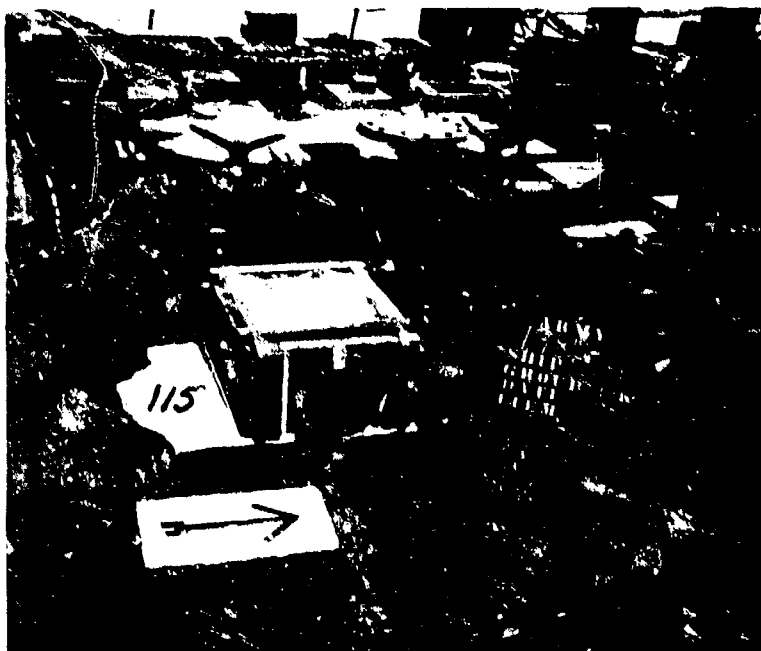
Fig. 333 - YOG 83 - Damage to Item 115 after Test Able.

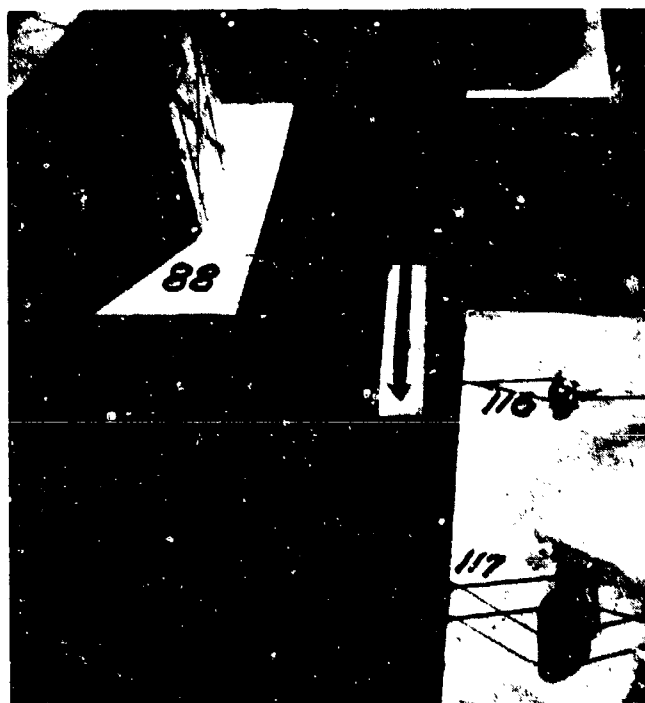
k. Fuse, Flare, M.T., M11A2, w/Booster (Item #116). One fuse was displayed bare, Fig. 334. On the YOG 83, it was corroded by rain, but no primary damage was apparent

Fig. 334 - IST 52 - Method of securing Items 88, 116, and 117.

h. Fuse, Flare, M.T., M111A2, w/Booster (Item #117). This item was displayed in a metal can, Fig. 334. On the YOG 83, Fig. 335 and Fig. 336, the paint was burned from the blast side of the can over an area approximately 1-1/2" x 3". The base of the can was also slightly scorched. The scorched area on the side was also rusted. The markings were partially scorched out. On the LST 52, the container was scorched on the blast side. It was dented by the straps, when secured to the pallet. No damage resulted on the other ships.

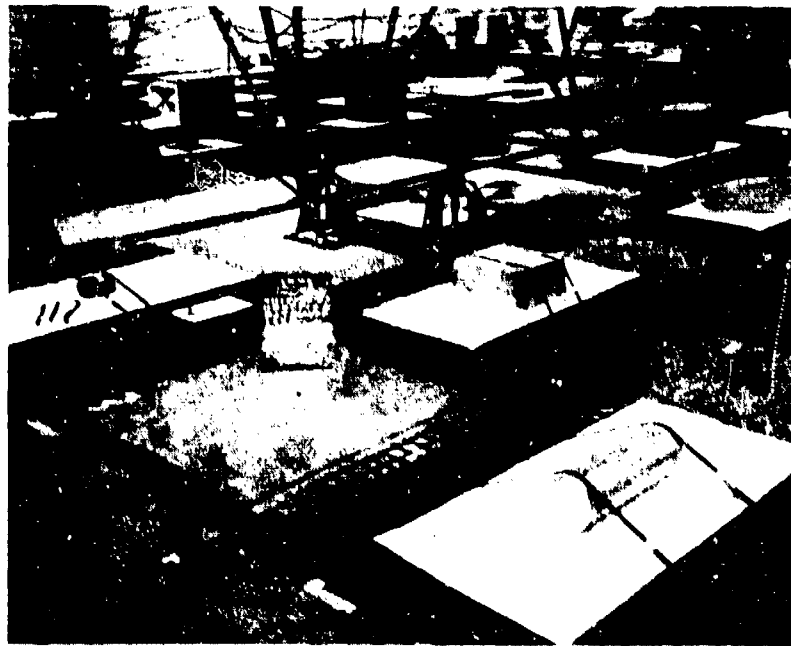
Fig. 335 - YOG 83 - Method of securing Item 117.

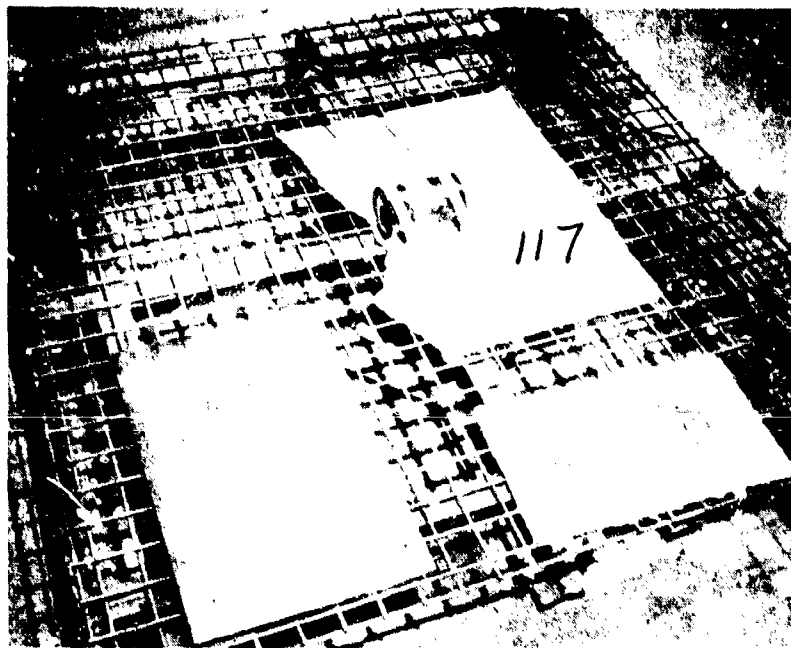
Fig. 336 - YOG 83 - Damage to Item 117 after Test Able.

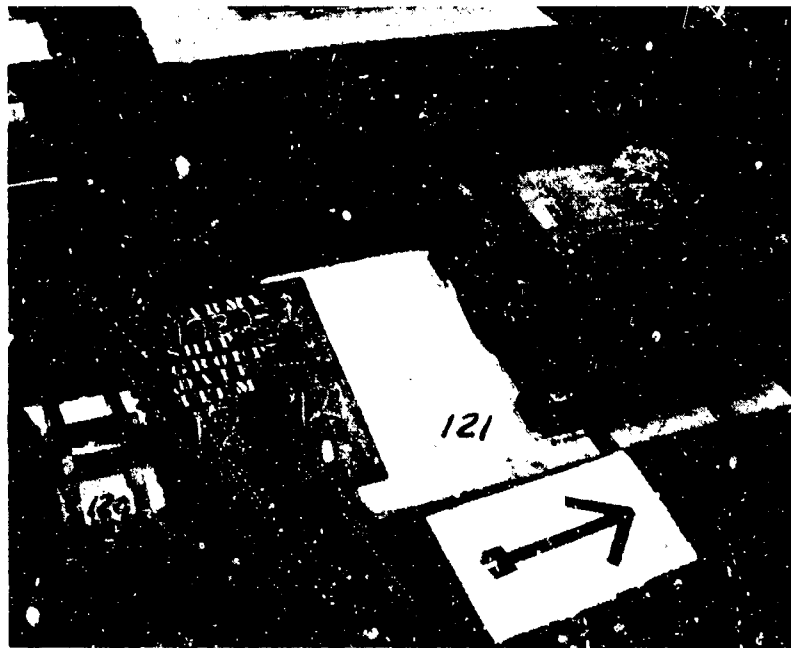
Fig. 339 - YOG 83 - Damage to Items 120 and 121 after Test Able.

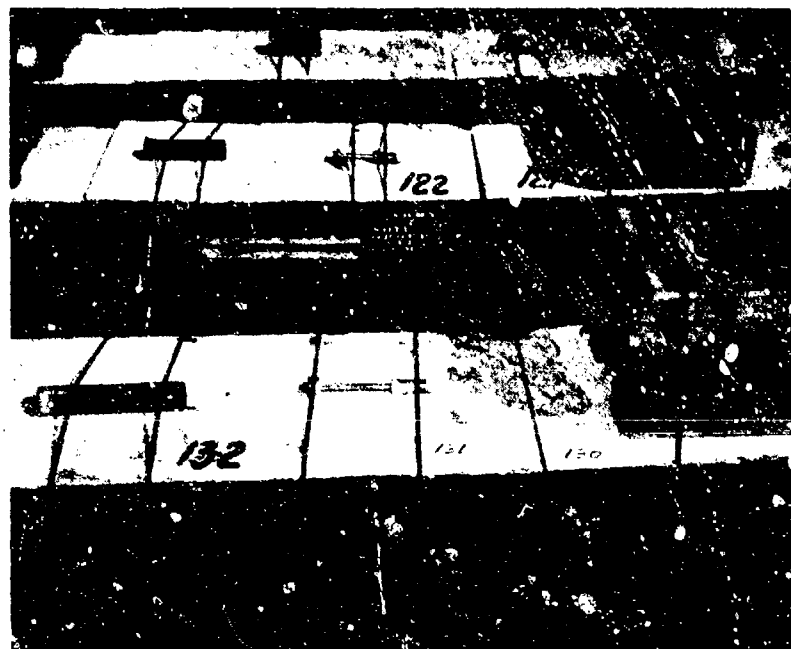
Fig. 340 - LST 52 - Method of securing Items 121, 122, and 132.

m. Fuse, Bomb, Tail, M112 (Item #112). One fuse was displayed bare on a metal plate, Fig. 340. On the YOG 83, slight corrosion was noted but there was no primary damage. The stem tube was slightly discolored. No damage was apparent on the remaining ships.

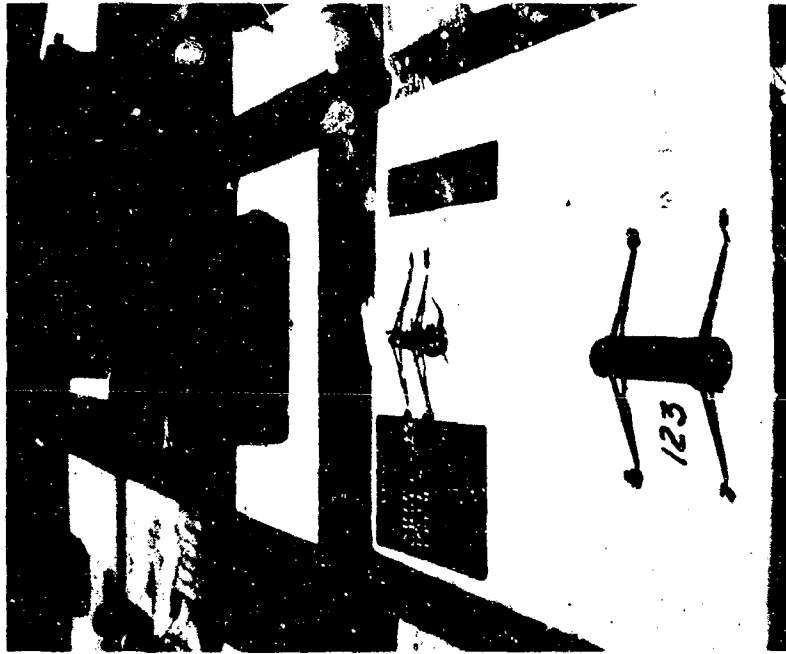
Fig. 341 - LST 661 - Method of securing
Item 123.

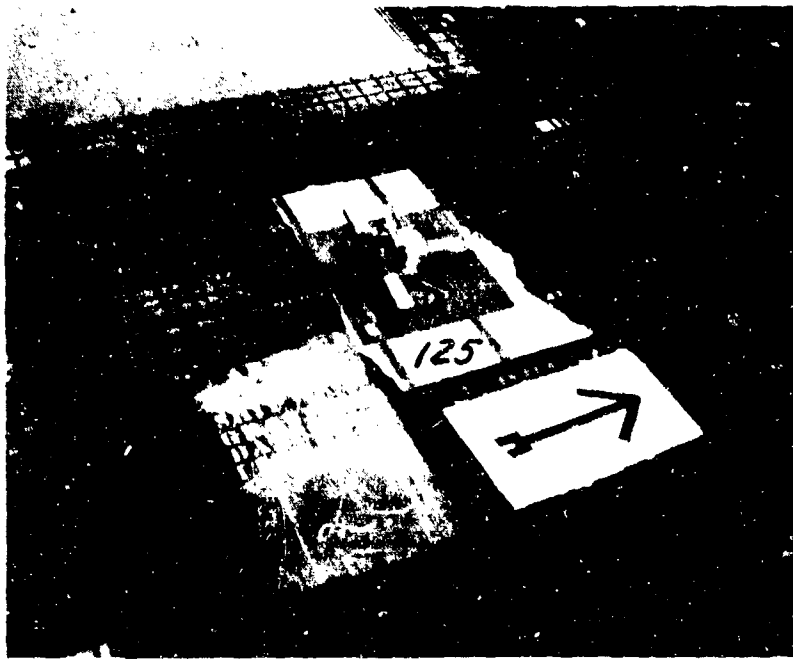
Fig. 343 - YOG 83 - Damage to Item 125 after Test Able.

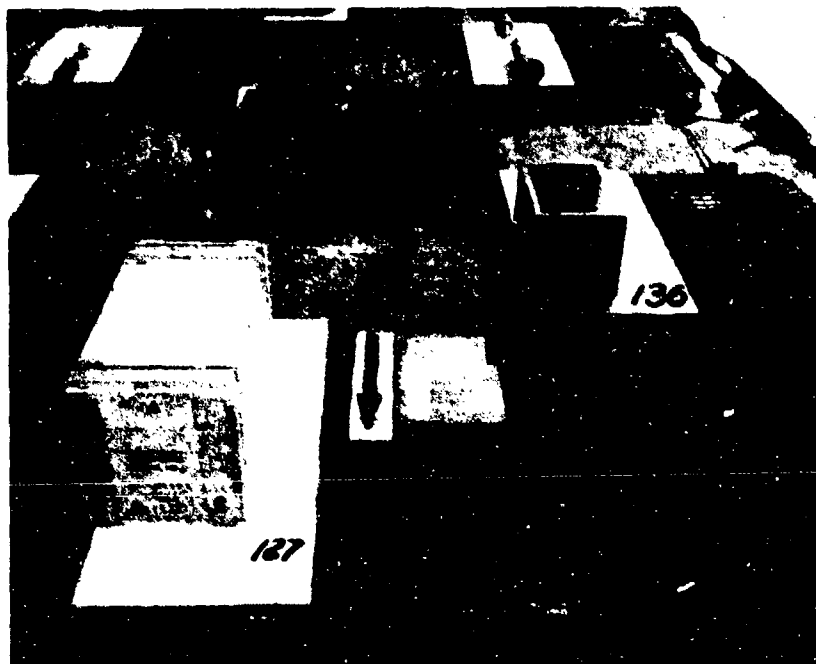
Fig. 346 - LST 53 - Method of securing Items 127 and 136.

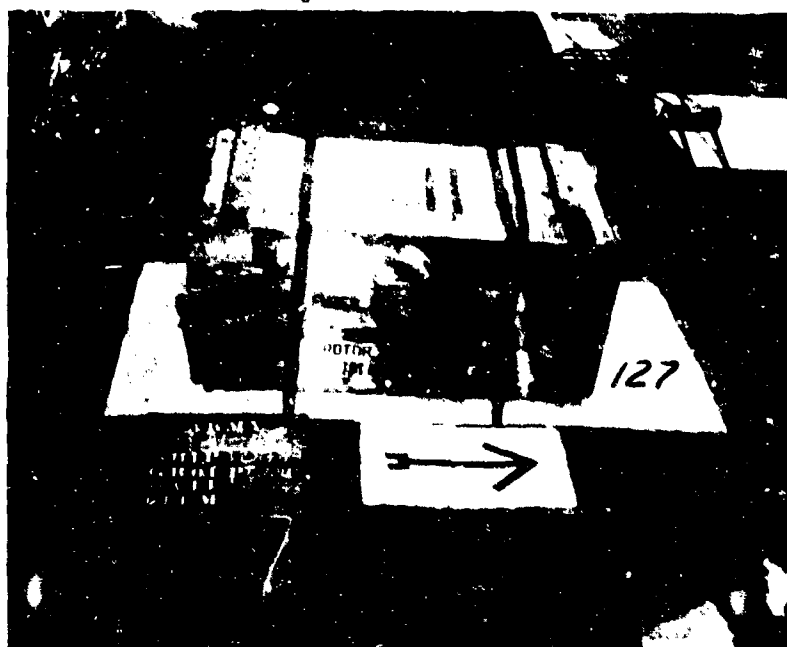
Fig. 347 - YOG 83 - Damage to Item 127 after Test Able.

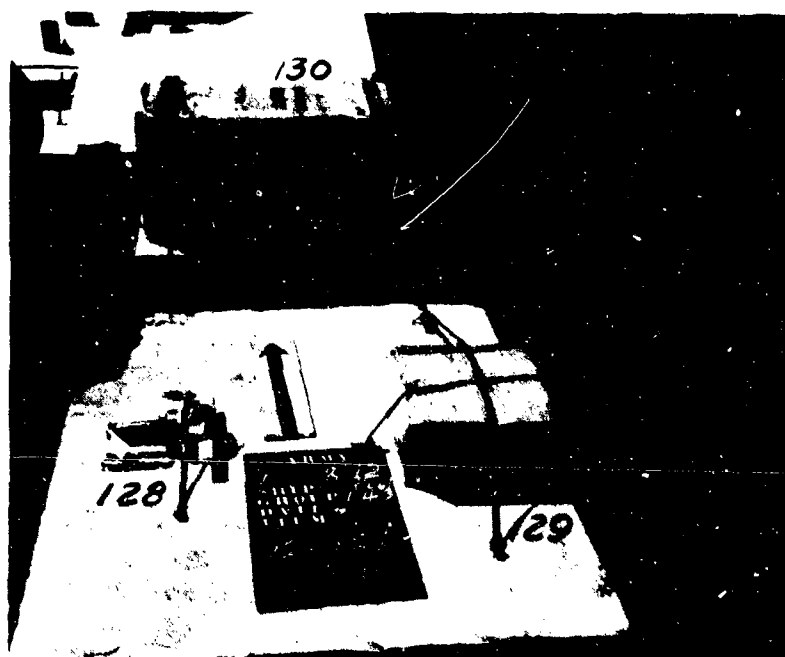
g. Fuze, Bomb, Nose, VT, T51E1 (M166) w/o Booster (Item #128). One fuze was displayed bare, Fig. 348. On the YOG 83, the plastic head was scorched. The warning tag was only partially legible. The fuze was slightly corroded. On the LST 52, the plastic head was slightly melted. No damage was apparent on the other ships.

t. Fuze, Bomb, Nose, VT, T51E1 (M166) w/o Booster (Item #129). One fuze was displayed in a cardboard carton, Fig. 348. On the YOG 83 and the LST 52, the carton was scorched on the blast side. No damage was apparent on the remaining ships.

Fig. 348 - LST 661 - Method of securing Items 128, 129, and 130.

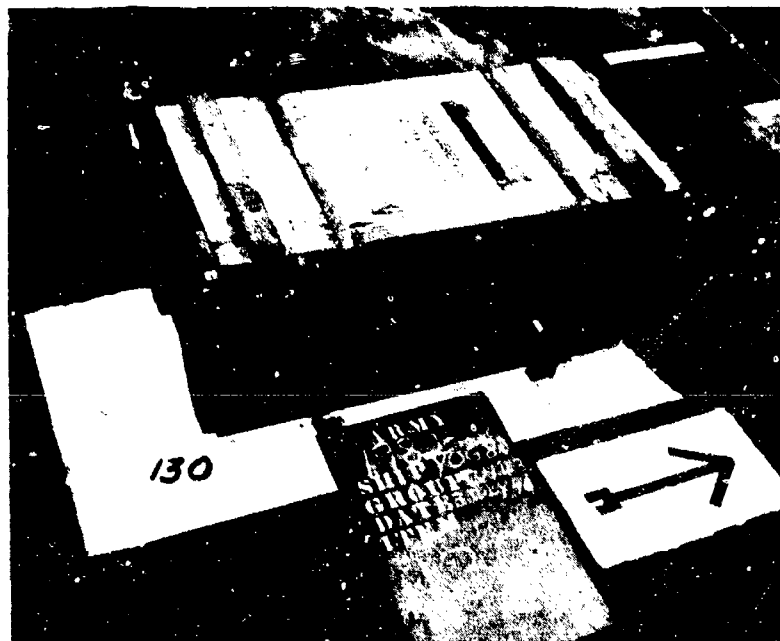
Fig. 350 - YOG 83 - Test Able damage to Item 130.

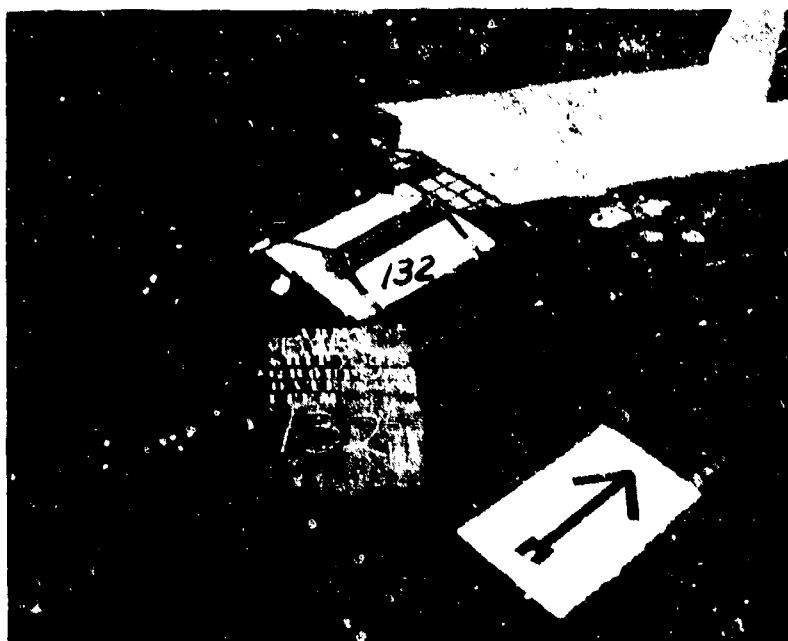
Fig. 353 - YOG 83 - Damage to Item 132 after Test Able.

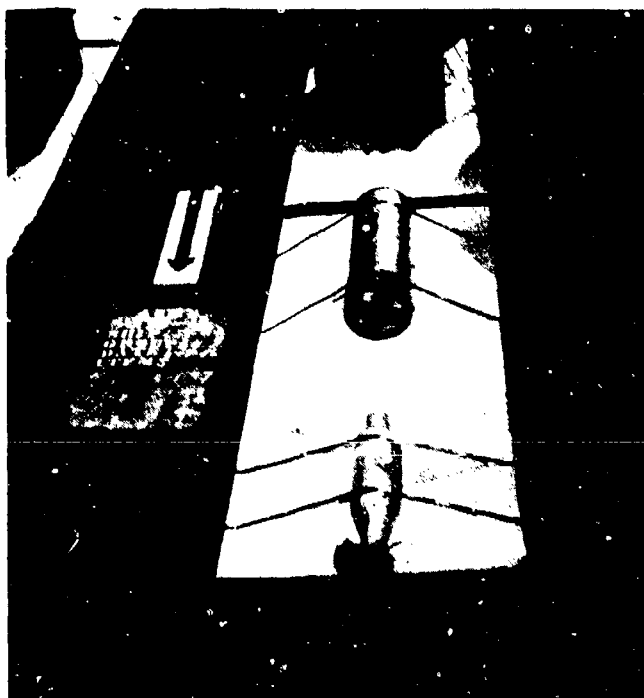
x. Fuze, Bomb, Tail, T57 (Item #133). Four fuzes were displayed in a box, Fig. 354. On the YOG 83, Fig. 355 and Fig. 356, the blast side and ends were extensively scorched. The top was lightly scorched. The markings were illegible on the side and end but were legible on the top. On the LST 52, the box was

Fig. 354 - LST 52 - Method of securing Item 133.

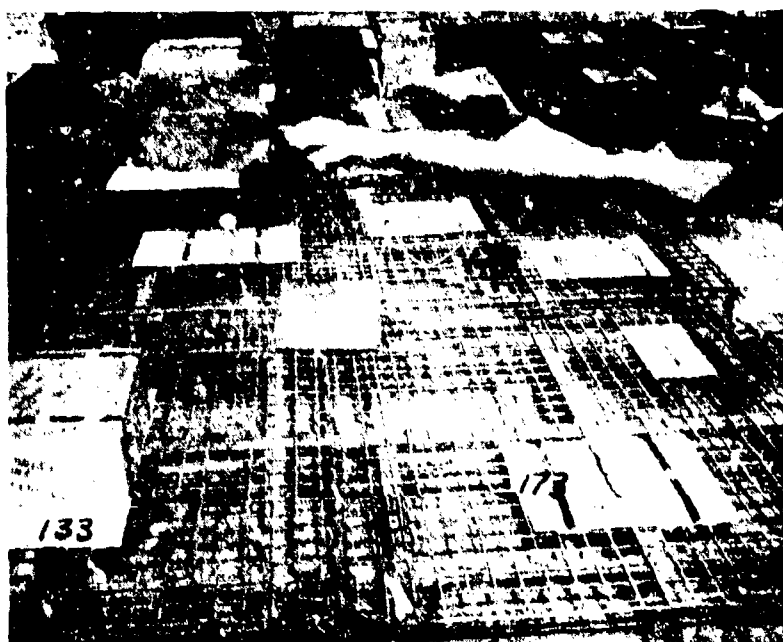
Fig. 355 - YOG 83 - Method of securing Items 133, 172, and 173.

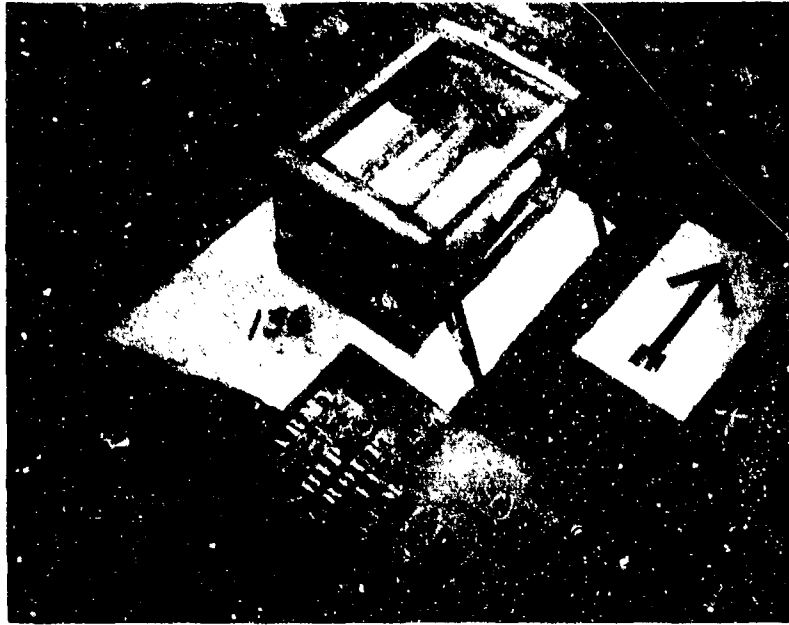
Fig. 359 - YOG 83 - Damage to Item 136 after Test Able.

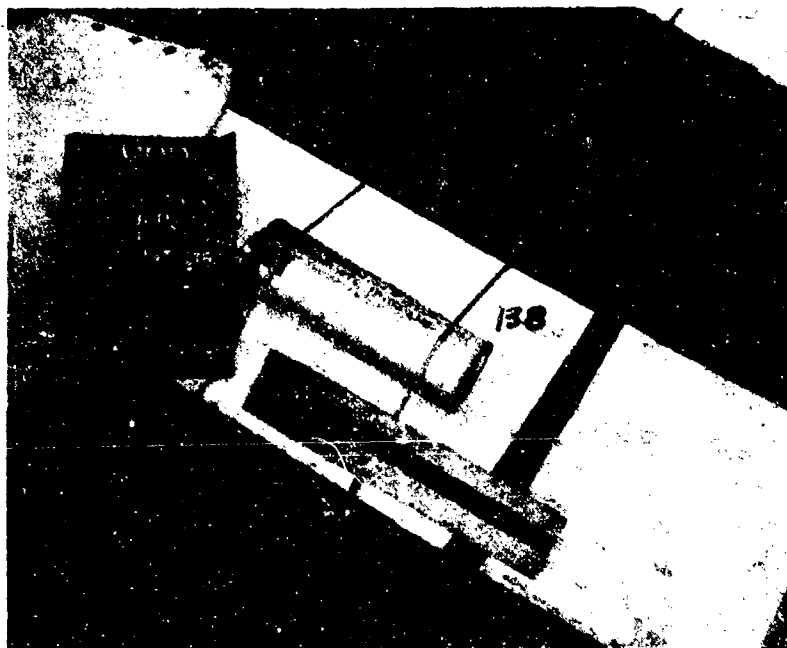
Fig. 362 - LST 52 - Damage to Item 138 after Test Able.

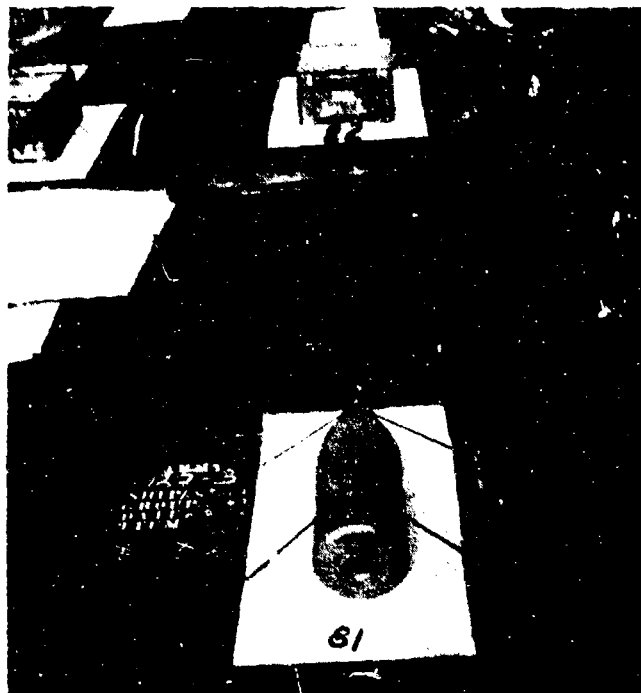
Fig. 363 - LST 661 - Method of securing Items 81 and 82.

a. Head, Rocket, HE, 7.2", T37, w/o Fuze (Item #81). One was displayed bare, Fig. 363. On the YOG 83, Fig. 364, rubber gasket between the motor adapter and the closure plug appeared to have been scorched and in so doing had discolored the adapter. There was rust on the front edge of the head. The head, on the LST 661, was masked. On all other ships no damage was apparent.

b. Head, Rocket, HE, 7.2", T37, w/o Fuze (Item #82). One was displayed in a wood box, Fig. 363. On the YOG 83, Fig. 364 and Fig. 365, one side was charred extensively, while the end was charred only slightly. Asbestos matting was spattered on the sides away from the blast. The box had shifted 1" with the blast. The lid had been displaced 3/8". A cleat on the severely scorched side was partially broken off. On the LST 52, the box was scorched on the blast side. Before Test Able, the lid was badly split. Some of the small pieces were missing. On the LST 661, the box was scorched on the side directly exposed to the blast. The markings on that side were obliterated. No damage was apparent on the LSTs 220 and 545.

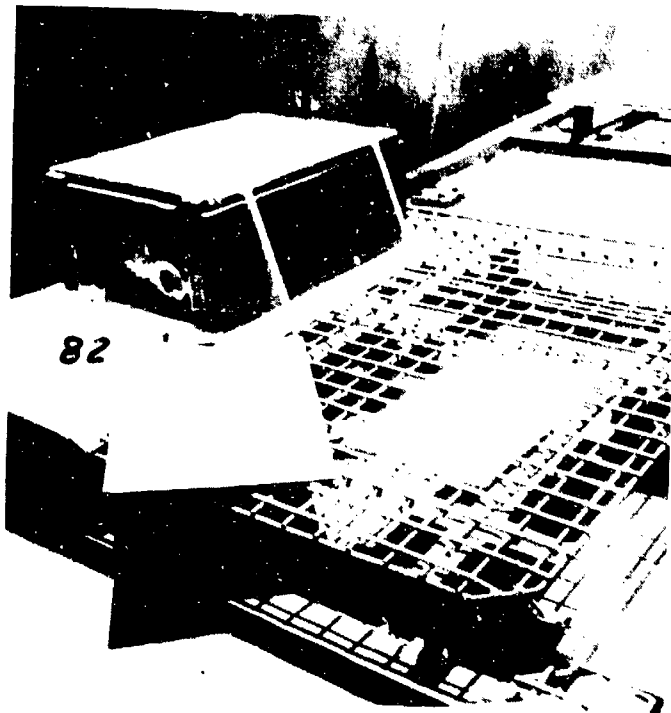
Fig. 365 - YOG 83 - Damage to Item 82
after Test Able.

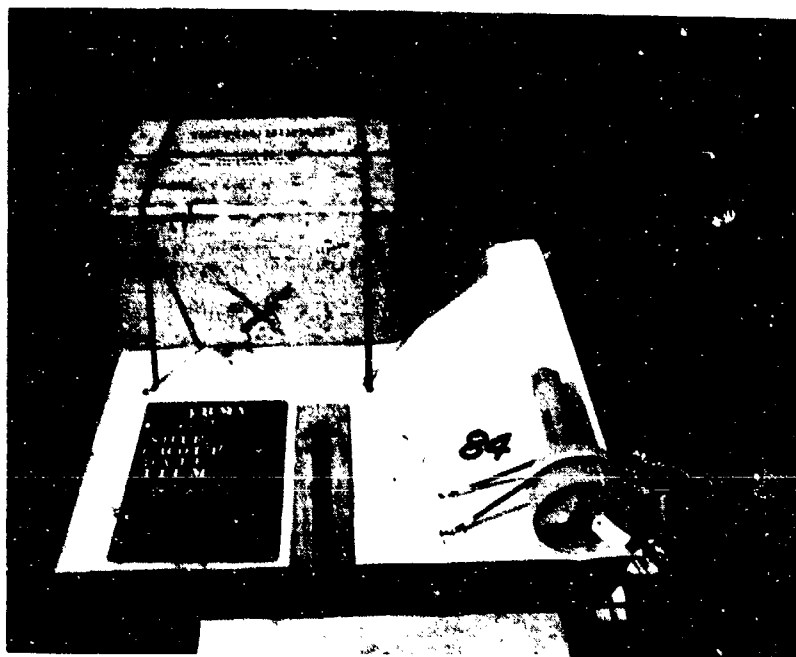
Fig. 366 - LST 661 - Method of securing Item 84.

c. Motor, Rocket, 2.25" MK3 (Navy) (Item #84). One motor was displayed bare, Fig. 366. On the YOG 83, the closing cap in the venturi was slightly scorched. The fins away from the blast were corroded. The shroud was spattered with asbestos on the side away from the blast. The item had shifted 3/8". On the LST 52, the motor was scorched on the side exposed to the blast. No damage was apparent on the LSTs 220, 545, and 661.

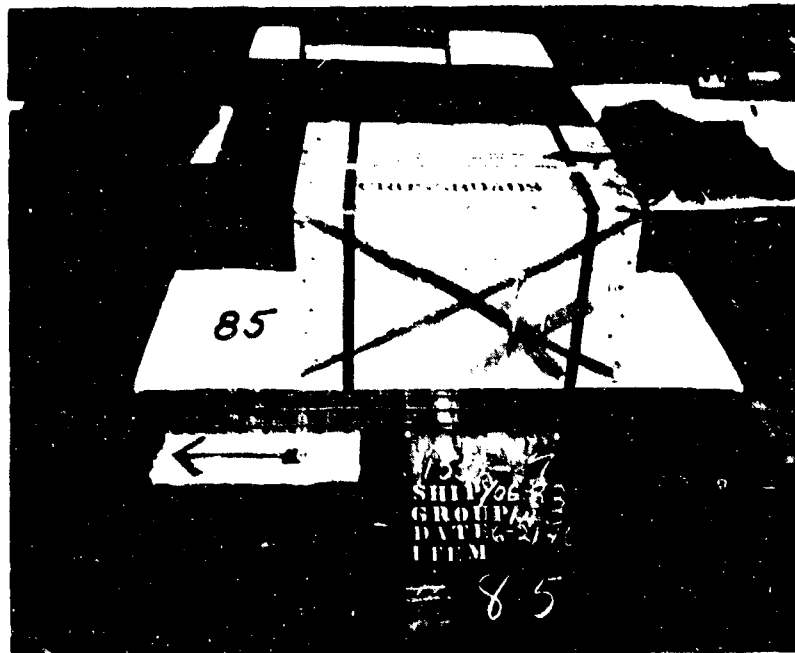
Fig. 367 - YOG 83 - Method of securing Item 85.

d. Motor, Rocket, 2.25", MK3 (Navy) (Item #85). Seven motors were displayed in a wood box, Fig. 367. On the YOG 83, the rear end, right side, and top were scorched and the markings were obliterated. The box was moved 1" by the blast. On the LST 52, Fig. 368, the box was scorched on the blast side and the box was moved 20" with the blast. The tie-down straps had been broken. On the LST 661, the box was scorched on the side directly exposed to the blast. The markings on that side were obliterated. No damage was apparent on the LSTs 220 and 545.
